Date visited 1/8/80Mine name(s) Sec. 24 (Glen & Edith) County McKinleySection NE $\frac{1}{4}$  24 Twnsh. 13 N. R. 11 W.Quadrangle sheet Bluewater 7 $\frac{1}{2}$ 'Mining district Ambrosia LakeElevation 7,100'Nearest city and/or dwellings Numerous single family dwellings clustered around Haystack Mtn., within 1 mile of mine.

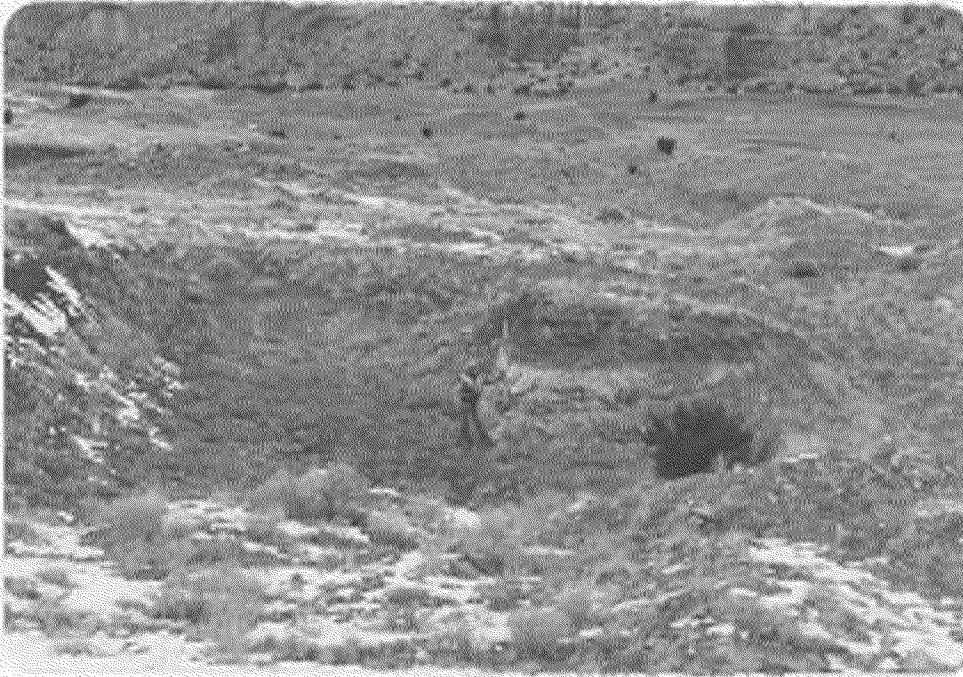
Photo (a) Looking NW into stripped area from SE edge of sec. 24 mine; note overburden piles at upper center and upper left extending for nearly 1,000' away from viewer. Mine trends NW.

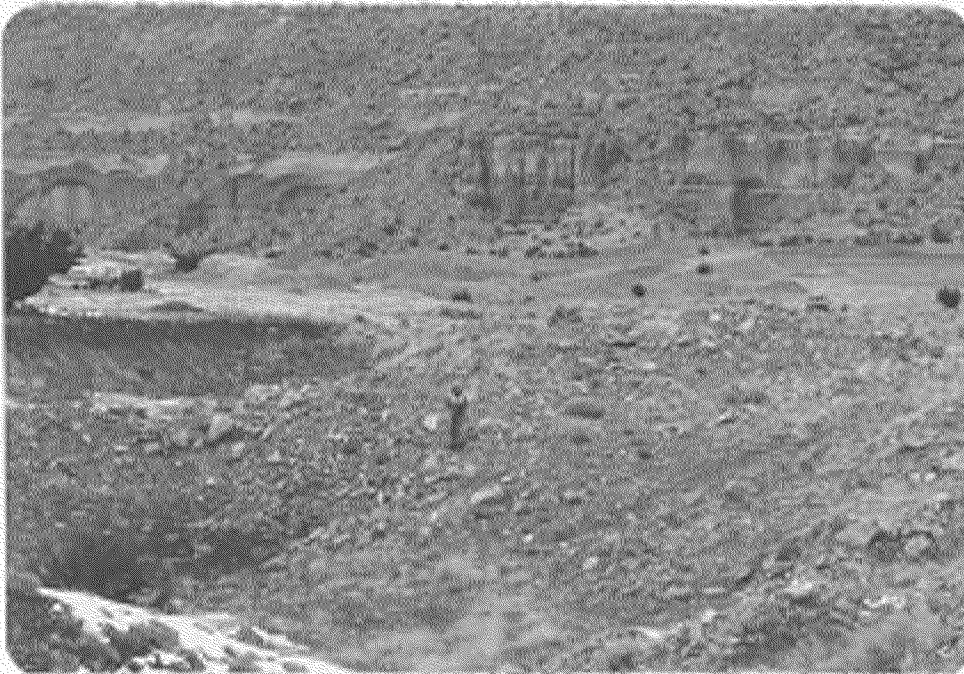
Photo (b) Looking again to NW, from within mine area, showing size and nature of individual pits; unconsolidated overburden is often more than 10' thick as seen in highwall below vehicle at left. Note large overburden and waste piles at center, middle distance.

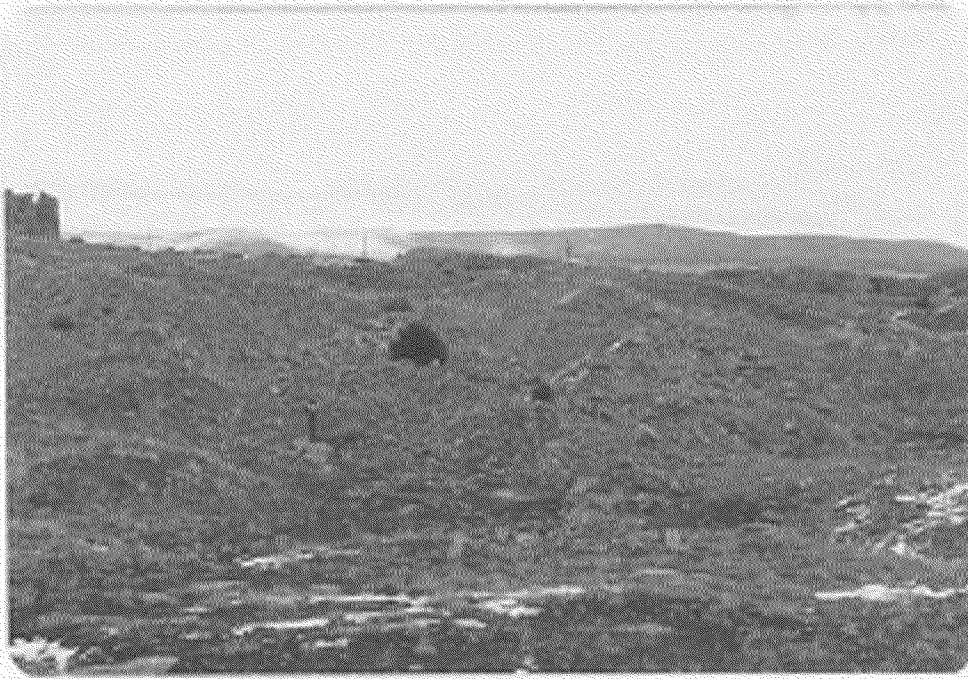
Photo (c) Looking NE at SE trending cut with waste piles on far side; note person at left for scale. Todilto Exploration Co., offices are just visible at left between last two utility poles.

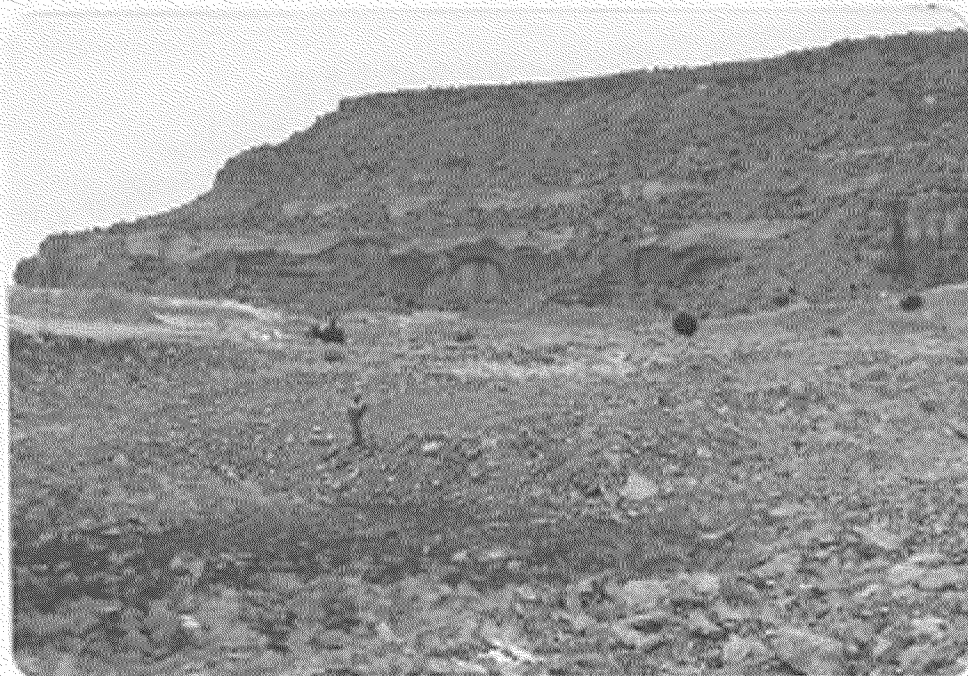
Photo (d) View to NW from small pit within the mine complex showing proximity of Haystack Mountain.

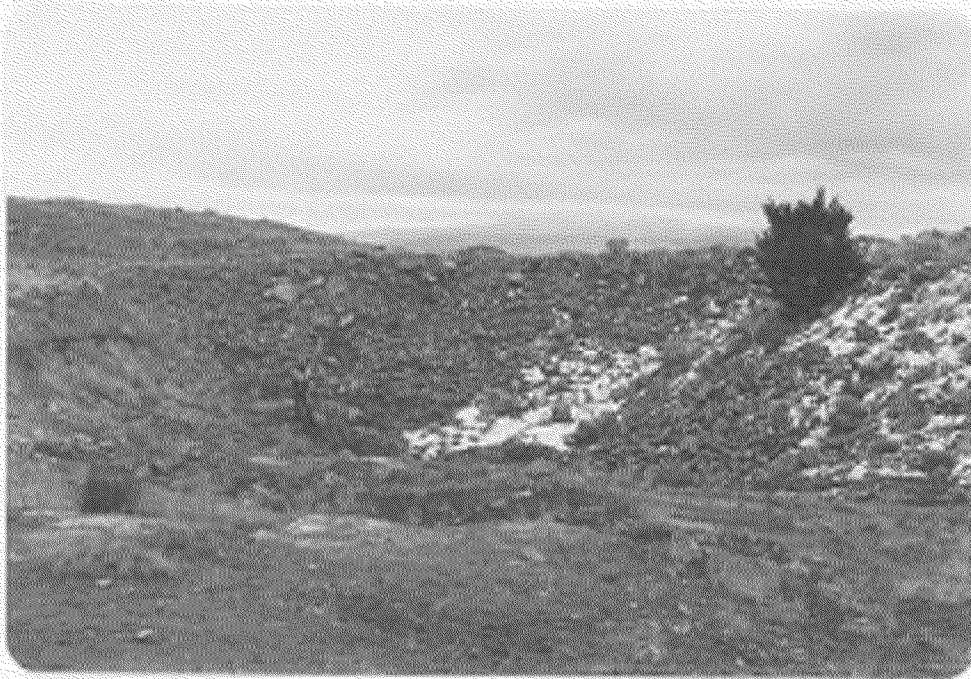
Photo (c) View eastward from near the center of the mine showing veneer of mine waste on slope behind shallow cut.

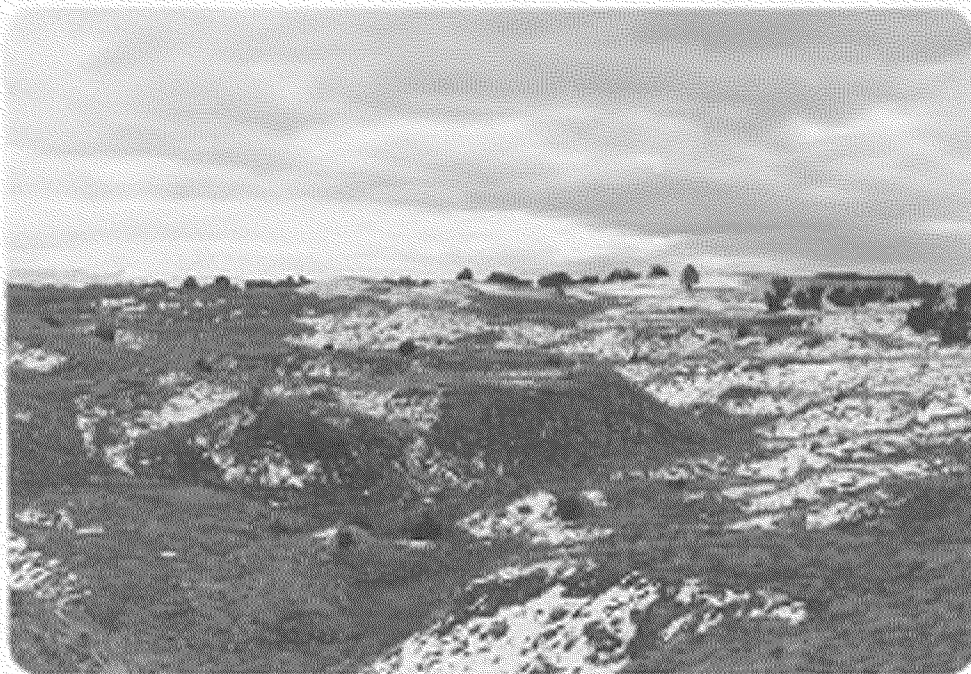
Photo (f) Looking SE back toward starting point in photo (a).
